Figure 3-1. Drainage Units and Features at and Near the Project Site

Figure 3-2. Floodplain Boundary at the Project Site

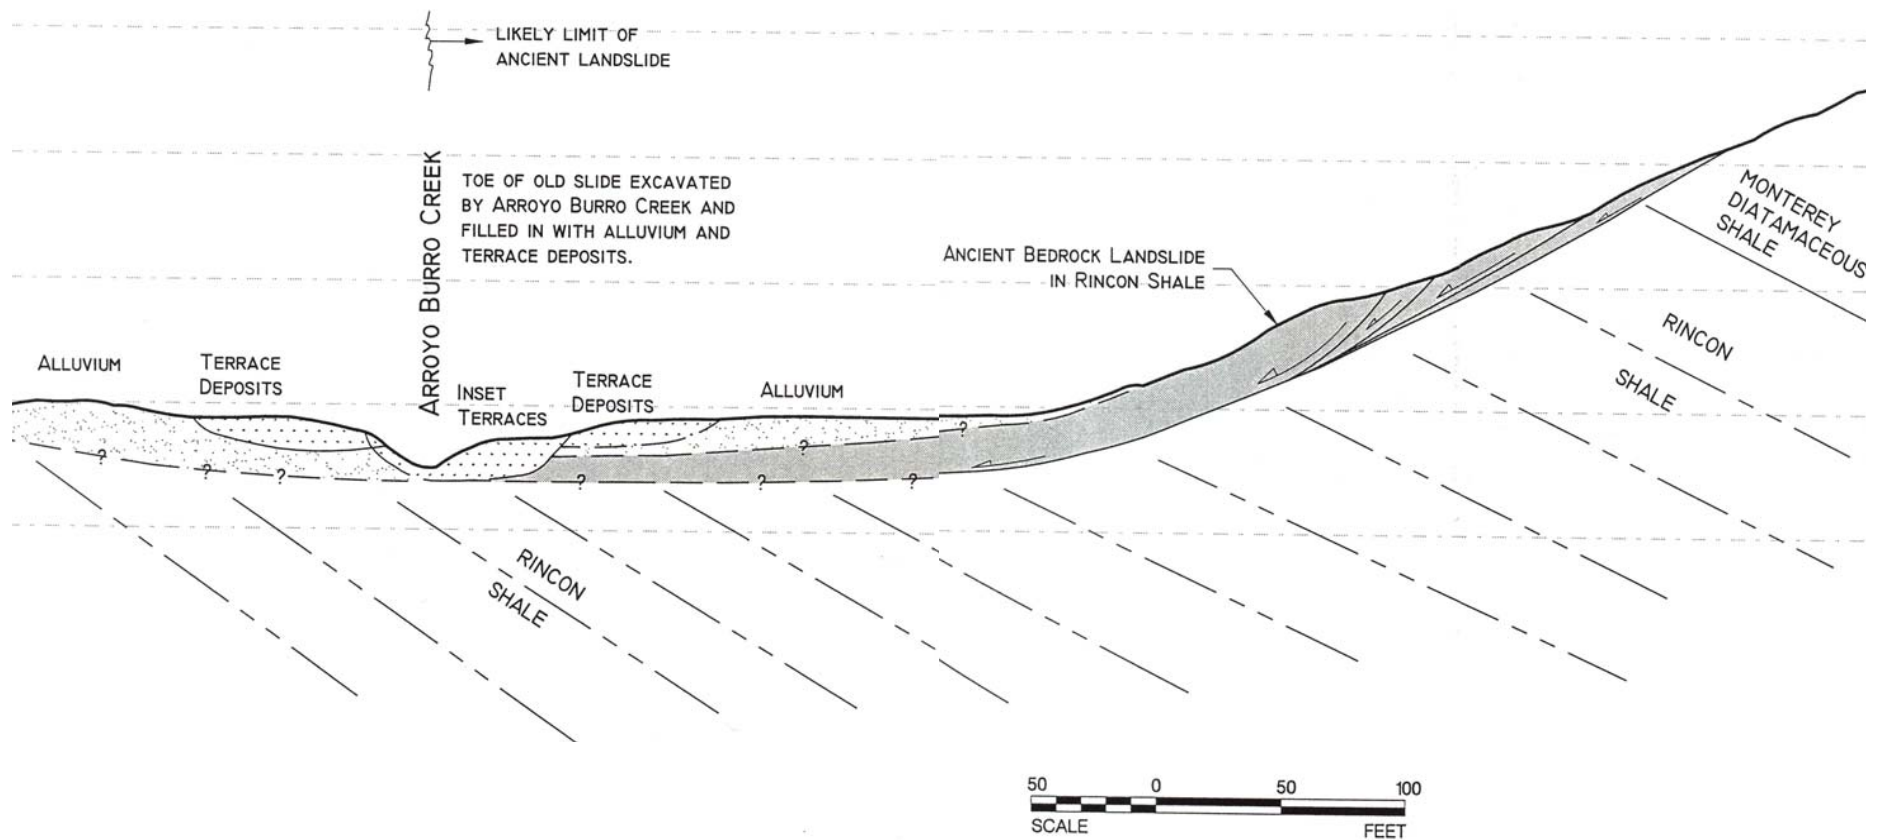
Source: Geolith Consultants (2000)

Figure 3-4. Cross Section of Arroyo Burro Bank Materials and Origin

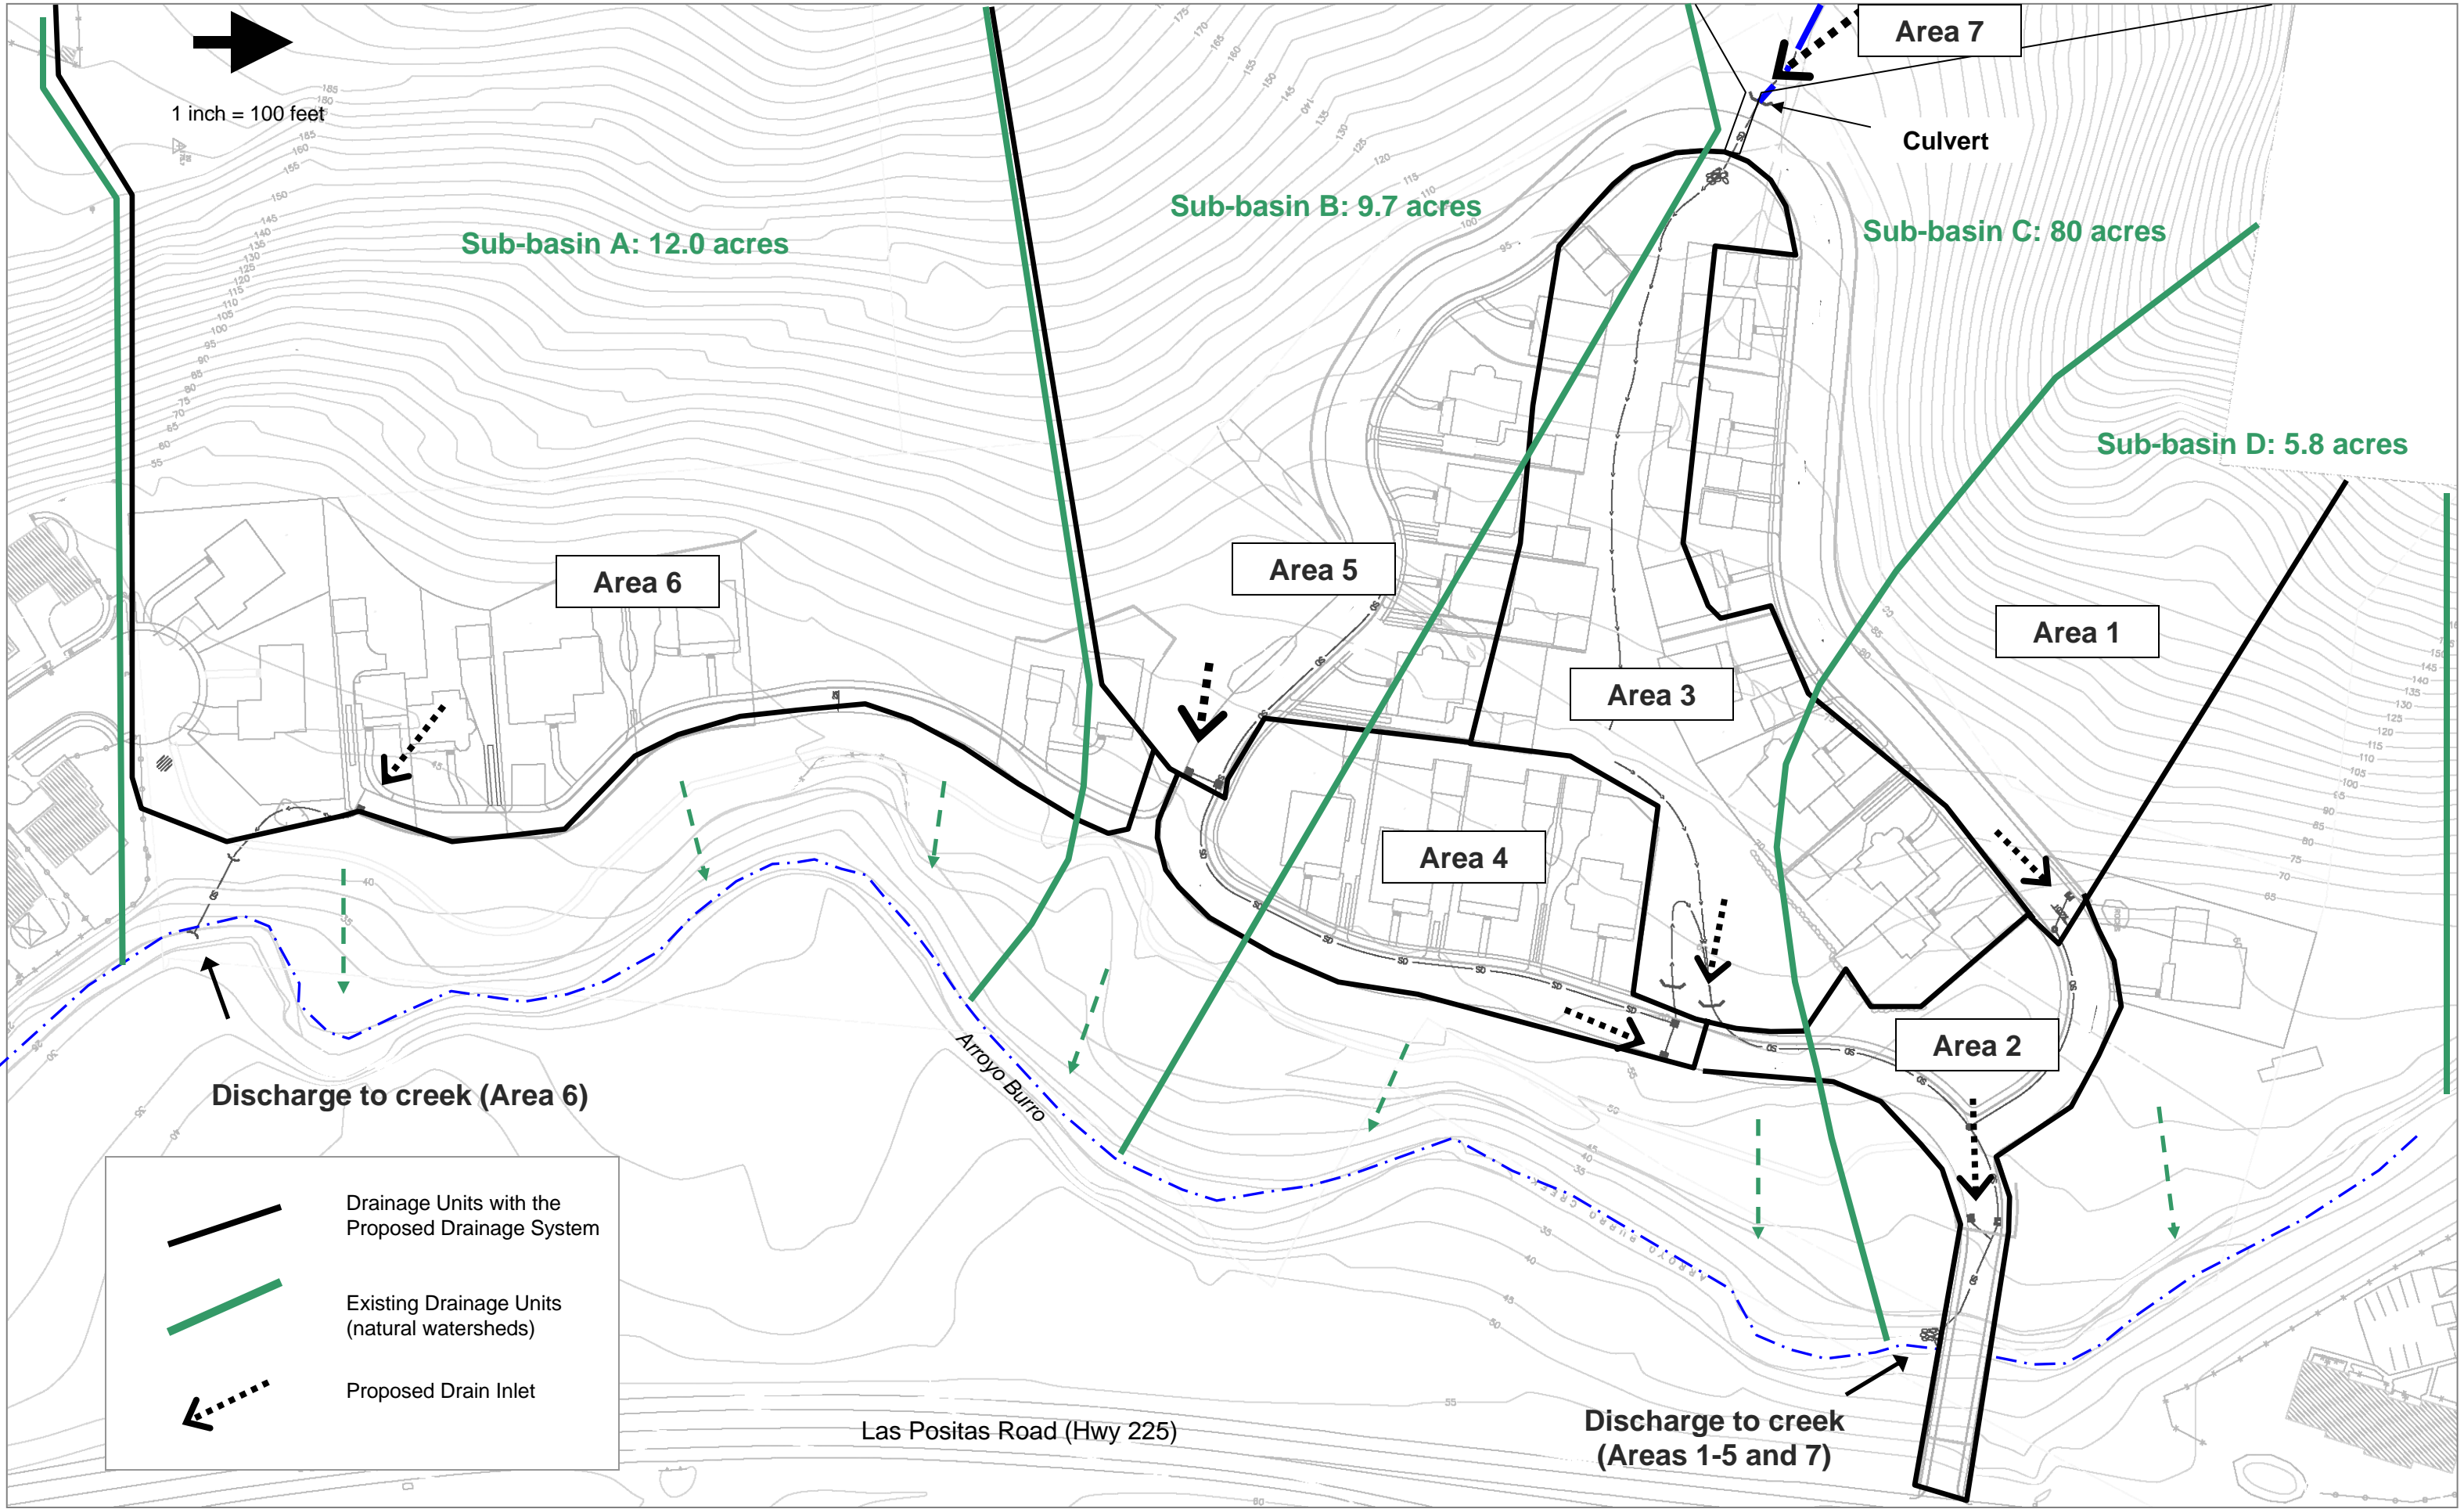
Figure 3-5. Change in Drainage Patterns at the Project Site

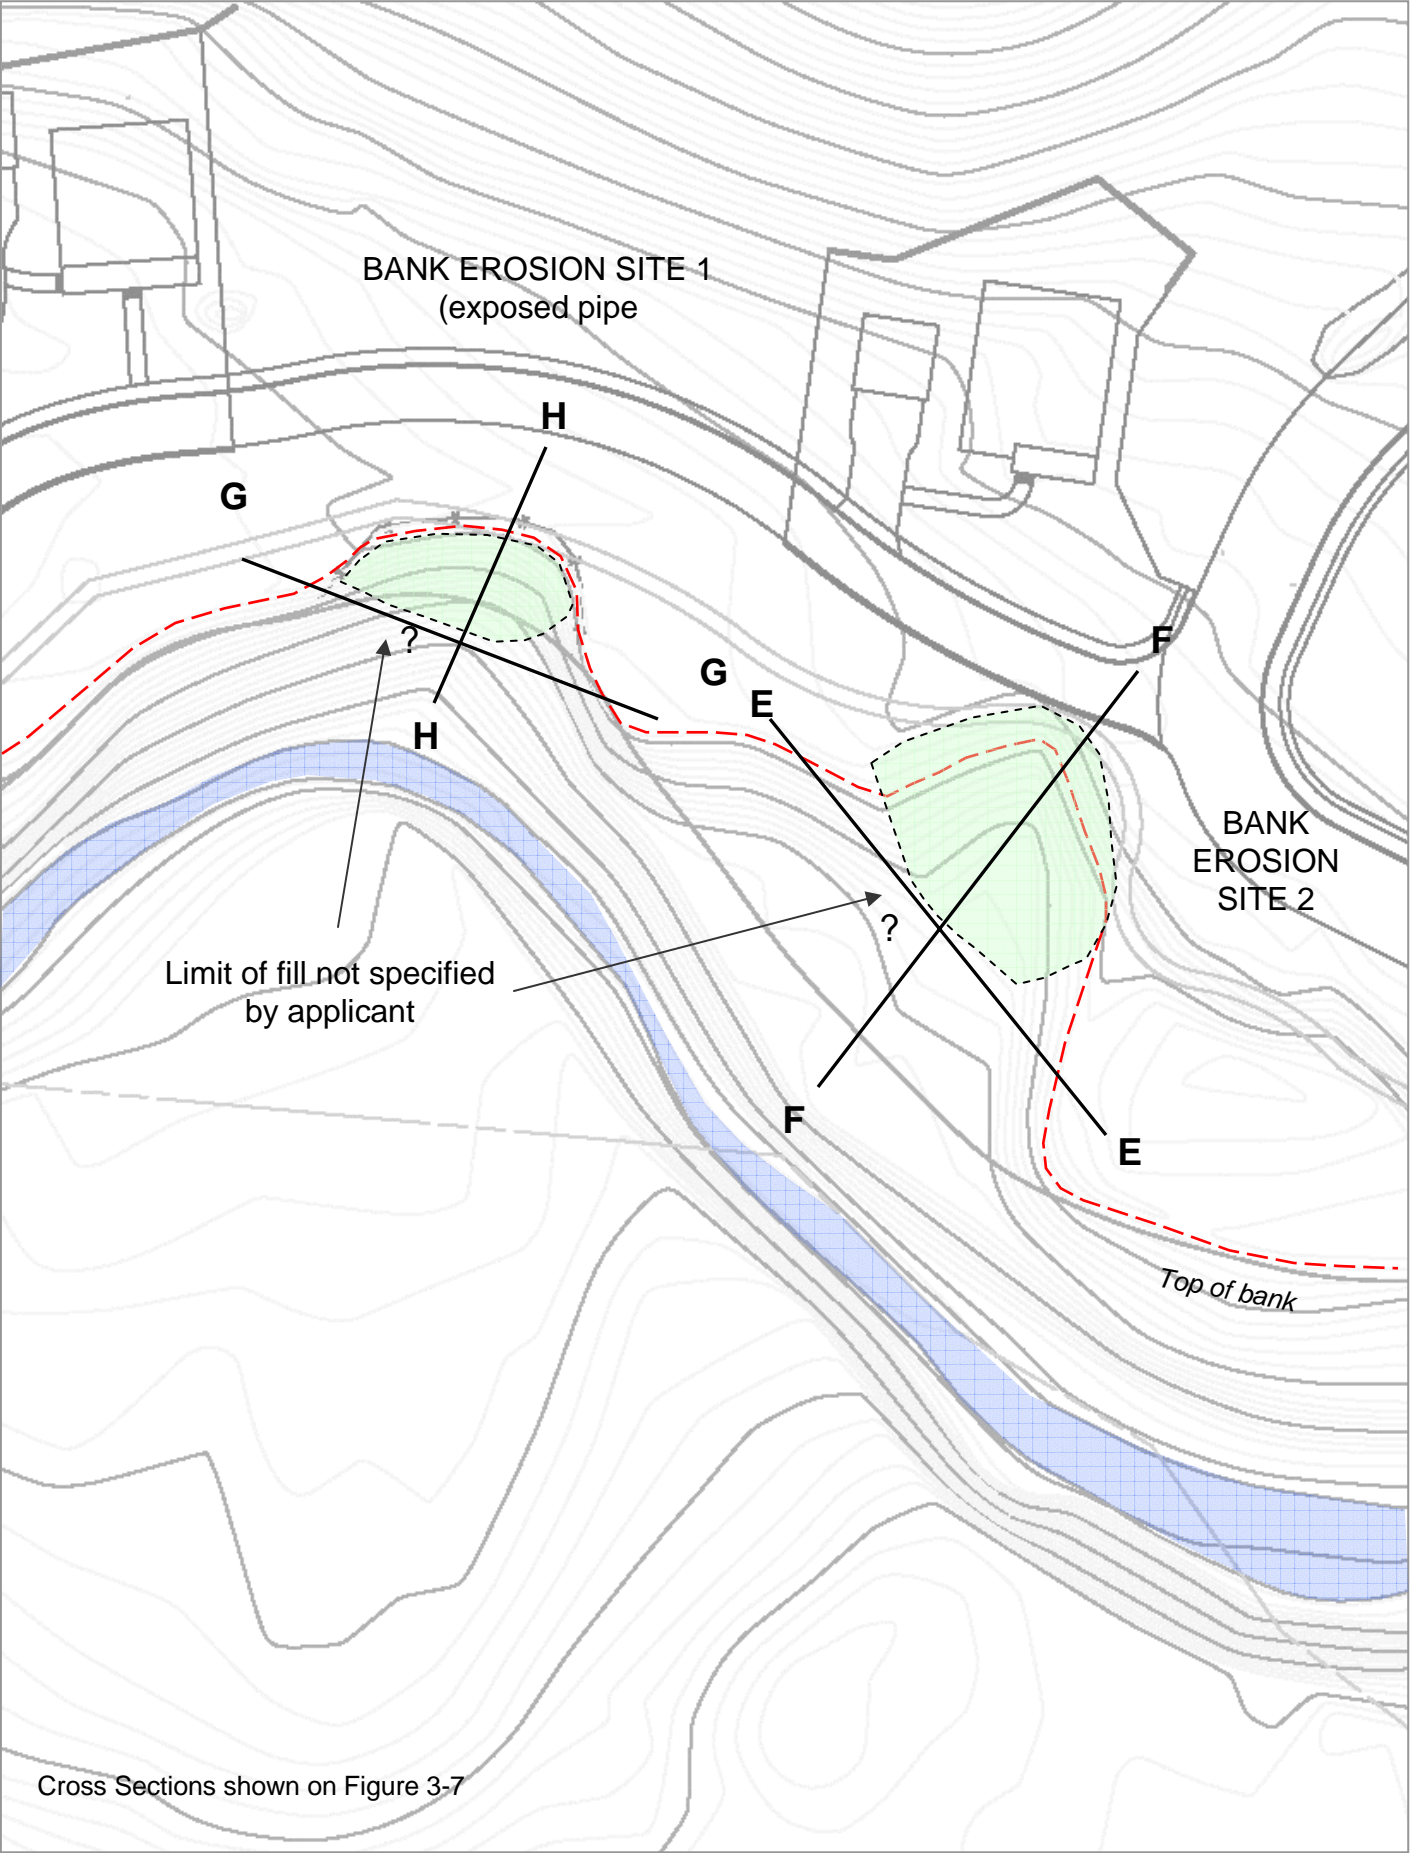
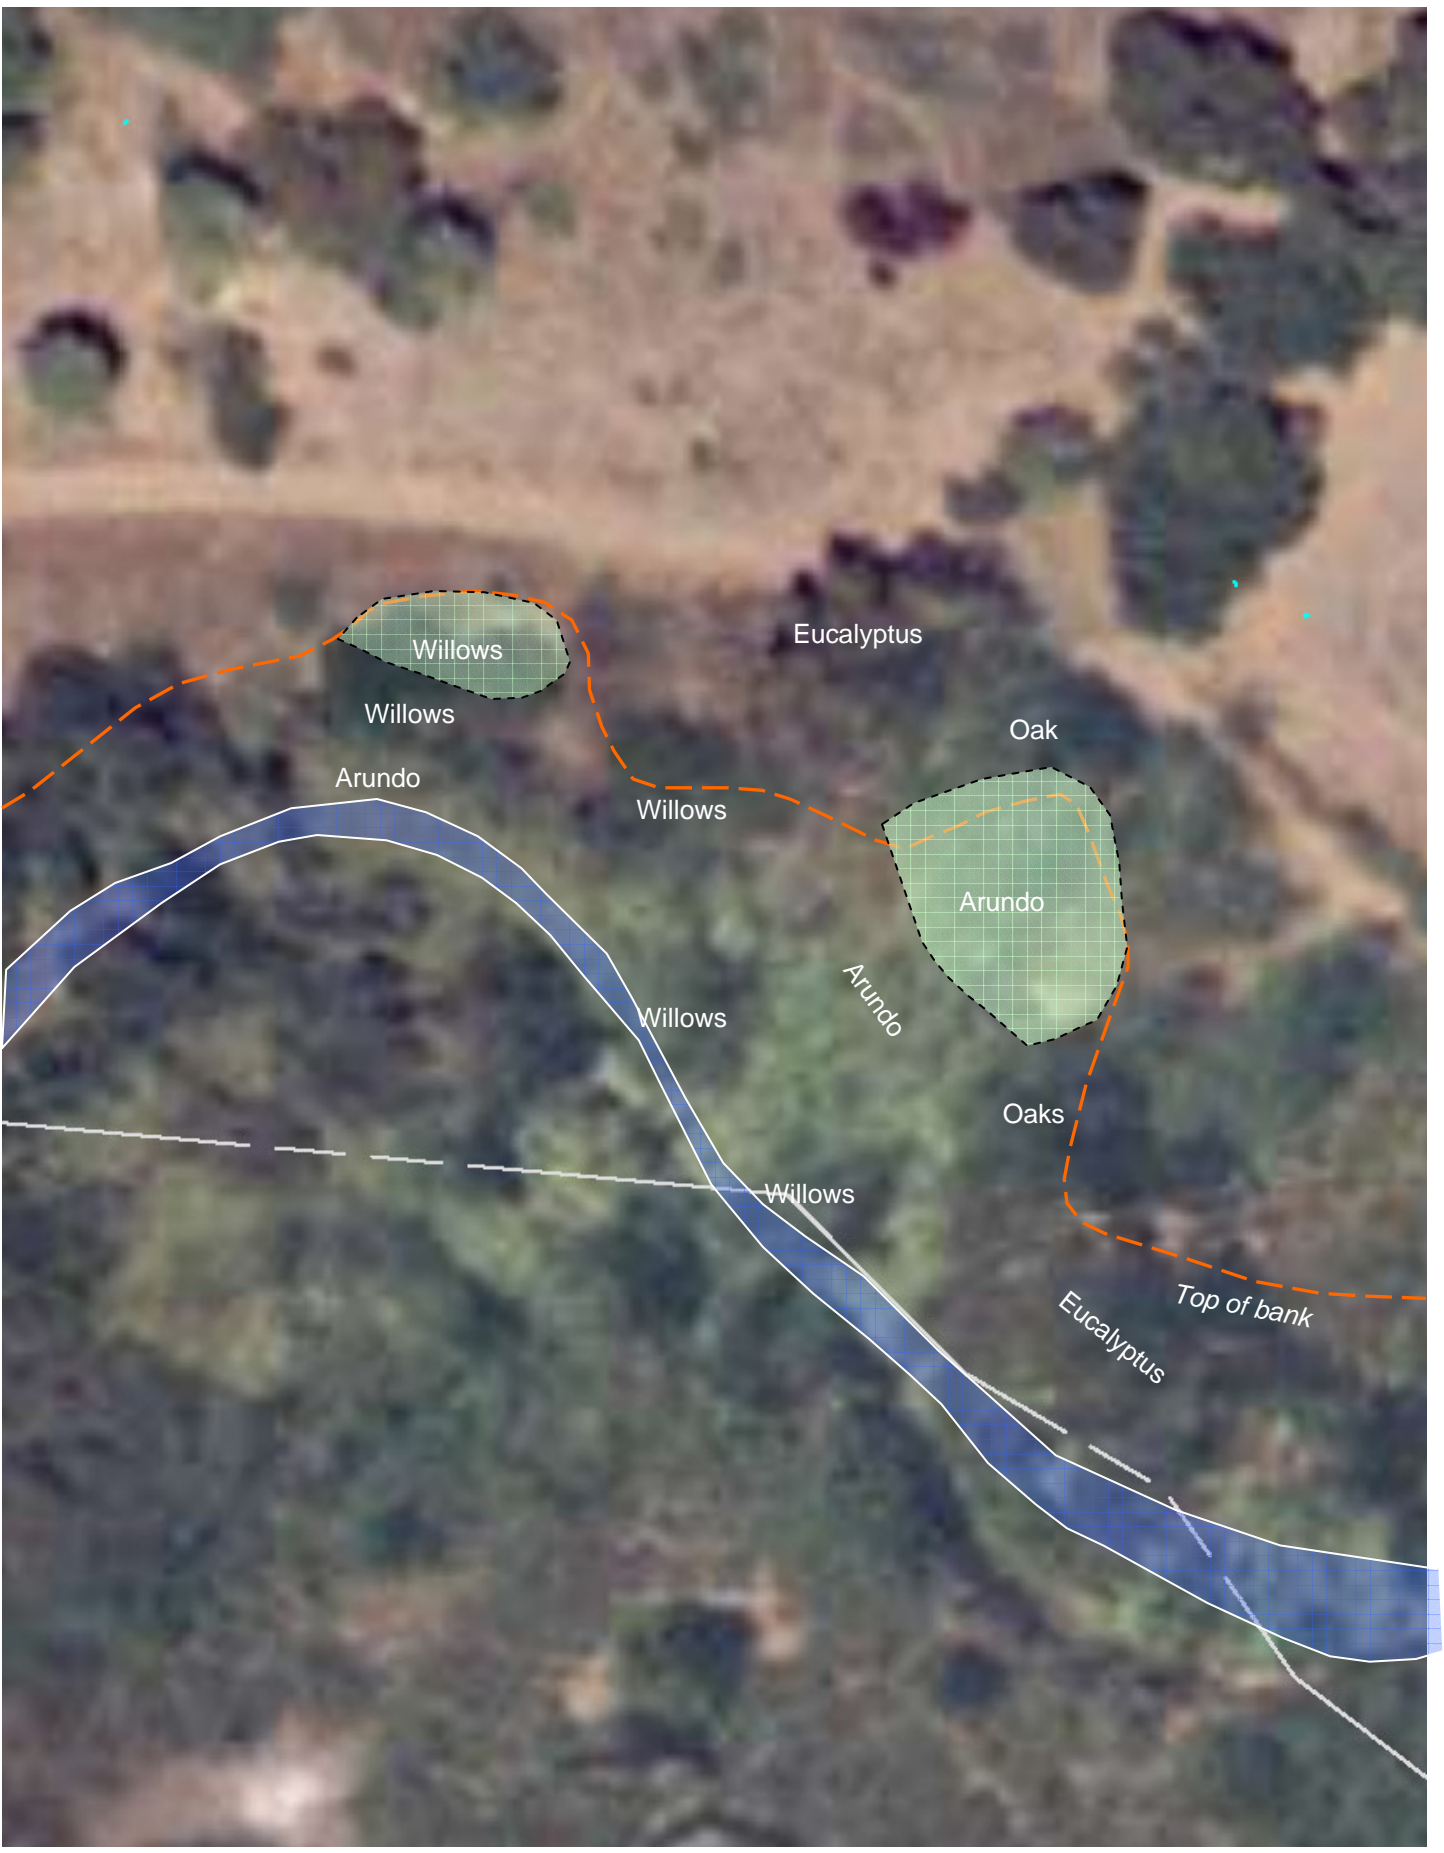
Figure 3-6. Proposed Creek Bank Restoration

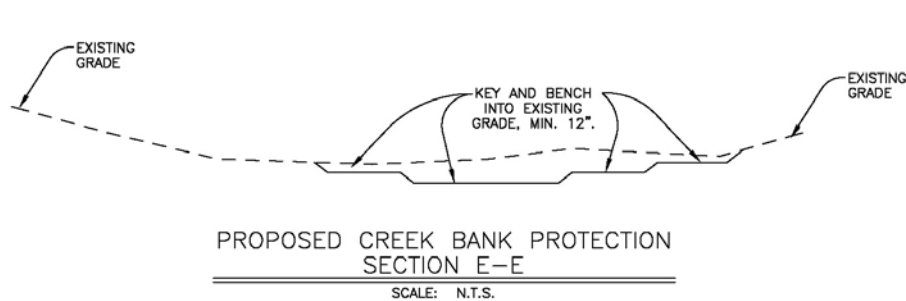
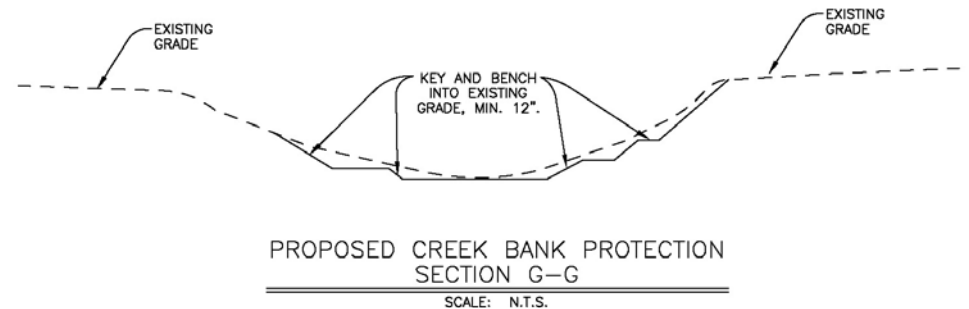
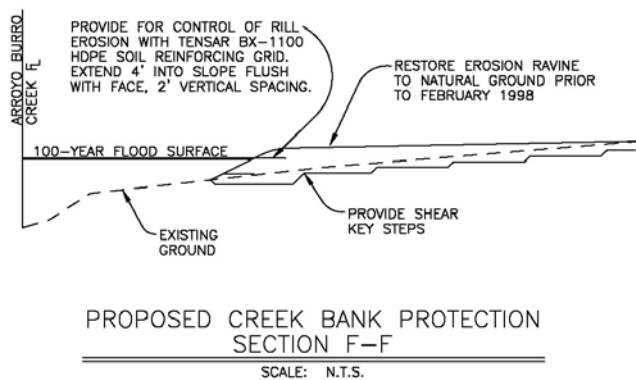
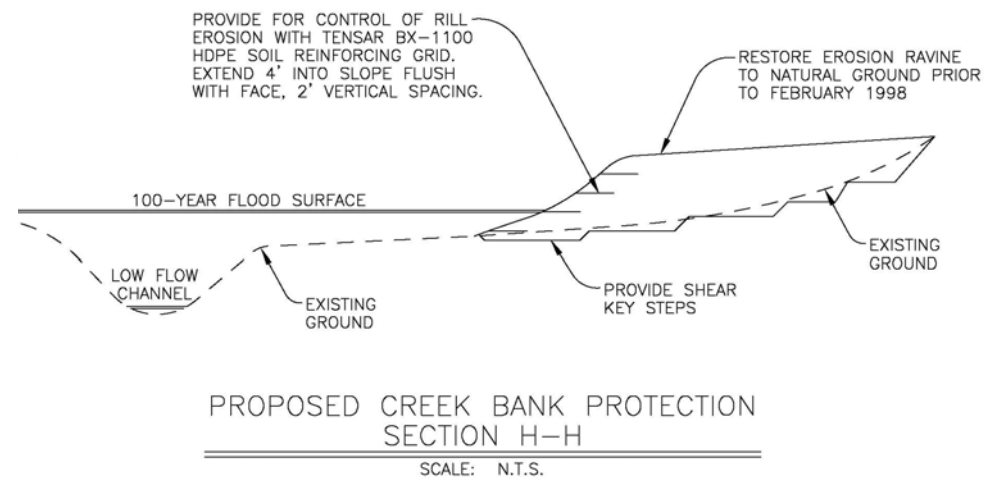
Cross sections shown on Figure 3-6

Figure 3-7. Cross Sections of Proposed Creek Bank Restoration
